National Highway Traffic Safety Administration

Case Vehicle (A): 1998 Mercury Type: Mystique GS, 4-door sedan

Vehicle (B): 1999 Toyota Type: Camry LE, 4-door sedan Driver: 22-year-old female

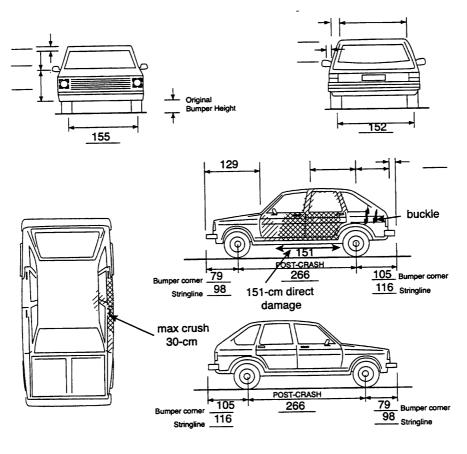
(Slide 6) The direct damage to vehicle (B) began at the driver door and extended 151-cm rearward along the left side. (Slide 7) The maximum crush was 30 cm to the driver door just above the sill. The left-upper and lower B-pillar and the left-lower C-pillar were deformed, and both left doors were damaged and jammed closed. The door windows were not broken, although the window frames were slightly deformed and pulled outward. (Slide 8) The left quarter panel was buckled, but there no was no other damage to the left side and no change in the left wheelbase. (Slide 9) There was no damage to the right side of vehicle (B) and no change in the right wheelbase.

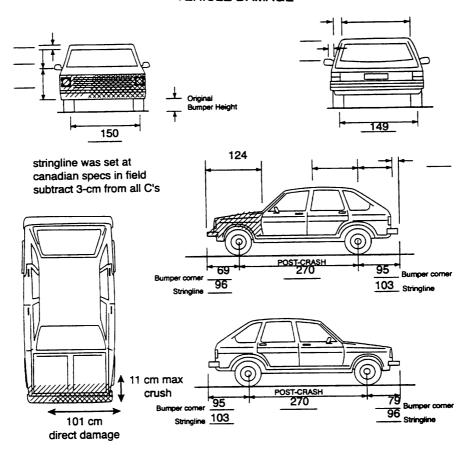
(Slides 4, 5) The direct damage to case vehicle (A) began at the left-front bumper corner and extended 101 cm along the front, resulting in 67-percent vehicle overlap. The maximum crush was 11 cm to the left-front bumper corner.

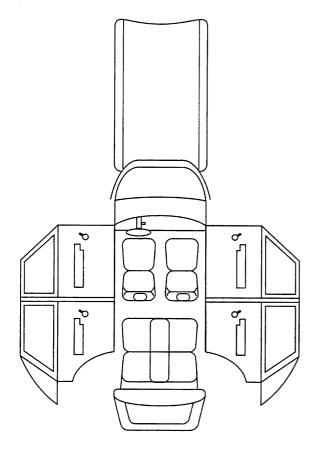
VEHICLE OCCUPANT CONTACT DIAGRAM

Interior	Occupant	Body		Confidence Level of
	Component	No. if	Region		Contact
Contact	Contacted	Known	if Known	Supporting Physical Evidence	Point
A	knee bolster	1	knee	scuff mark	1
В					
С					
D					
Е					
F					
G					
Н					
ı					
J					
М

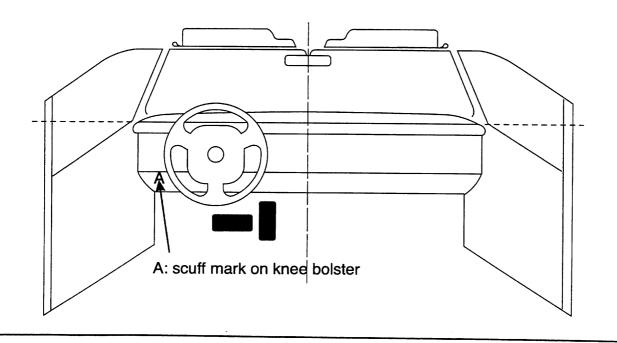
Driver belt: up-position on B-pillar no visible marks on webbing

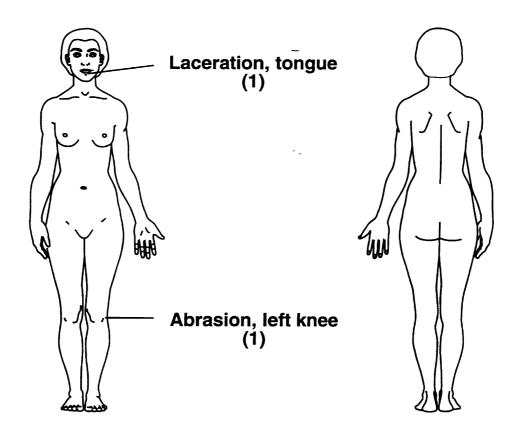
INDICATE LOCATION OF INJURIES.

Injury Source	
Injury Description	A.I.S.	Definite	Probable	Possible
Laceration, tongue	1	Bit with teeth		
Abrasion, left knee	1	Knee bolster		
Maximum A.I.S. Level	1			1
Injury Severity Score	2			·
